ESTABLISHING THE CAUSES OF PREMATURE DAMAGE OF STEAM TURBINE ROTOR BLADES OF TPP

Petro Solovei¹; Oleksandra Student¹; Lesia Svirska¹; Ivan Kurnat¹;
Sofia Krechkovska²; Taras Gural¹

¹*Karpenko Physico-Mechanical Institute of the National Academy of Sciences of
Ukraine, Lviv, Ukraine*

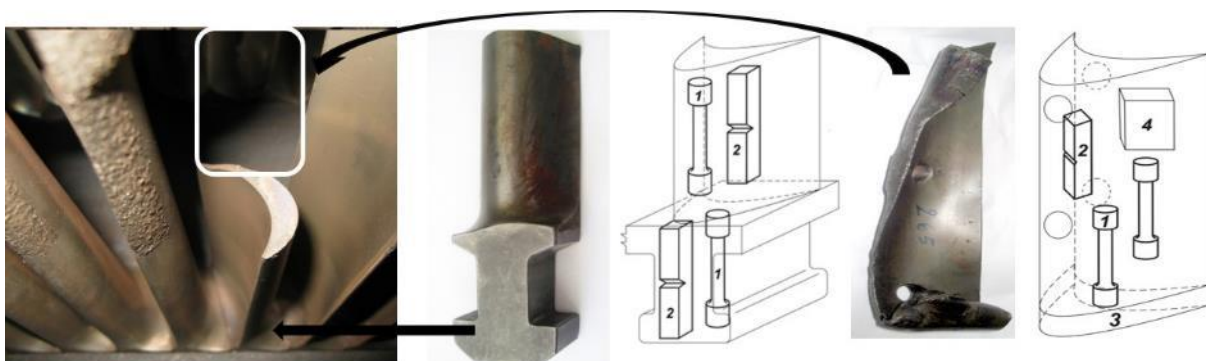
Figure 1. Macro view of broken blade and the scheme cutting of specimens for tensile (1) and impact (2) testing, the chemical composition estimation (3) and metallographic analysis (4)

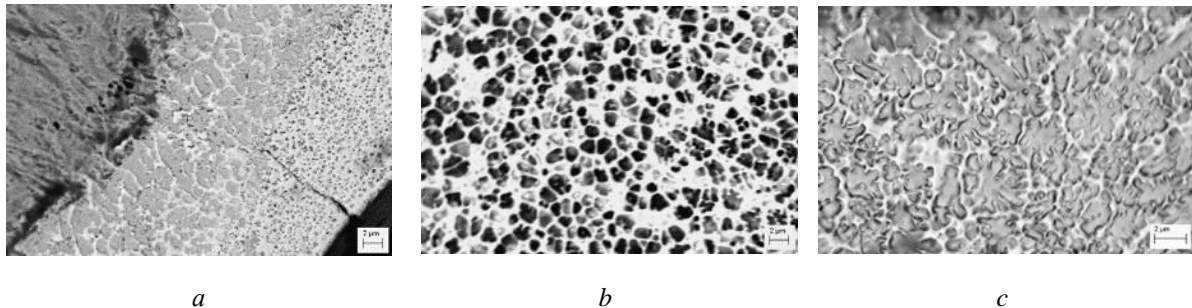
The macro heterogeneity of the surface hardened layer structure on the leading edge of the blade, obtained by the electrospark alloying method, porosity and uneven distribution of carbides of refractory elements in the cross-section were noted. The thickness of this layer varied and was a maximum of 160 μm near the leading edge of the blade and a minimum of 45 μm on separate sections of its convex surface (Fig. 2). Refractory tungsten carbides or intermetallic compounds (of the Fe_7W_6 type) in the hardened layer were located along the boundaries of columnar grains of ferrite highly alloyed with chromium, approaching the boundary with the base metal of the blade (Fig. 2 a). Their morphology is determined by the direction of heat removal during the cooling of molten metal microvolumes at the contact points of the electrodes during electrospark alloying with the cold surface of the blade plate. As the distance from the blade surface increased, the grains in the layer structure became rounded, and the spherical tungsten carbides became comparable in size to them (Fig. 2 b). At an even greater distance from the blade base metal, chromium carbides were released from the highly

chromium-alloyed matrix (Fig. 2 c). Their clusters formed star-shaped elements on the background of the alloyed matrix, and small tungsten carbides were found only occasionally along their boundaries. Bands with similar structural features alternated throughout the thickness of the layer.

Figure 2. Microstructure of the surface hardened layer on the leading edge of blade

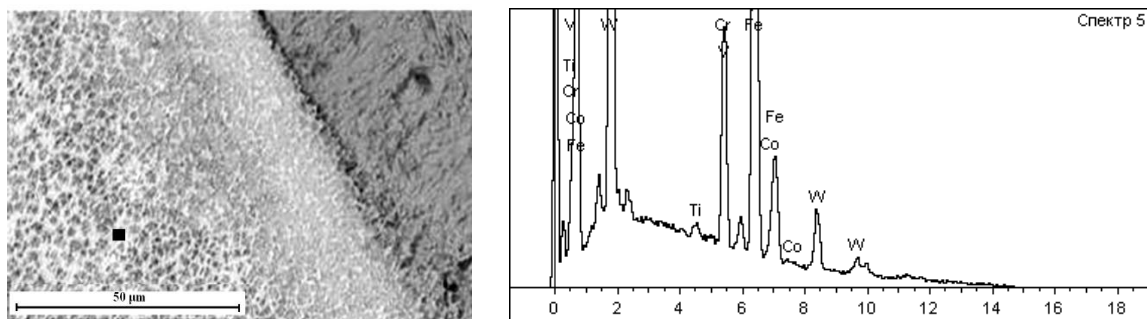
By X-ray microspectral analysis it was established (Fig. 3) that the main alloying elements of the surface hardened layer obtained by the electrospark alloying method were Ti, Co, Cr, W. In the surface hardened layer of the blade, the average content of elements was, wt. %: 1.8 Ti 2.2 Co, 10.1 Cr and 29.7 W. Moreover, the lighter the areas in the cover structure, the higher the content of W and Cr and the lower the content of Fe, and vice versa when the areas are darker. Bright white inclusions in the electrospark alloyed surface hardened layer had an increased content of Cr and Fe and were therefore considered to be tungsten carbides or intermetallics. Areas of light gray background corresponded to chromium doped ferrite.

Figure 3. X-ray microspectral analysis of the blade surface hardened layer

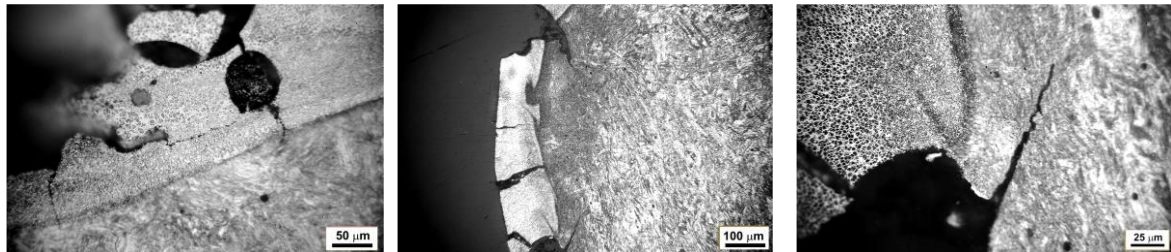
A significant number of large round pores was noticed on the surface of the blade layer hardened by electrospark alloying technology. Their maximum size reached 30 μm (Fig. 4a). The growth of cracks was recorded from almost all observed pores, due to which gave it was possible to consider them as ready-made stress concentrators that facilitated the nucleation of fatigue cracks in the surface layer and, accordingly, their propagation into the blade body (Fig. 4b, c). Such technological defects of steam turbine blades were considered one of the main reasons for their premature destruction [28, 29]. These cracks were recorded on the transverse section. It is obvious that on the axial grind, due to the favorable tensile load scheme of the leading edge of the blade, it was possible to record a larger number of cracks (including those that would grow into the body of the blade). In particular, on the surface that corresponded to the fracture surface of one of these cracks, oriented across the blade plate and located slightly below the

surface of the cutting wheel (therefore not damaged during its manufacture), the characteristic signs of fatigue crack propagation, namely, small fatigue grooves could be seen. It was located at a distance of almost 5 mm from the leading edge on the side of the convex surface of the blade. Based on the analysis of defects in the surface layer of the blade, it was considered that the presence of large pores could cause its fatigue cracking during operation.

Figure 4. Cracks in the of the surface hardened layer of the blade

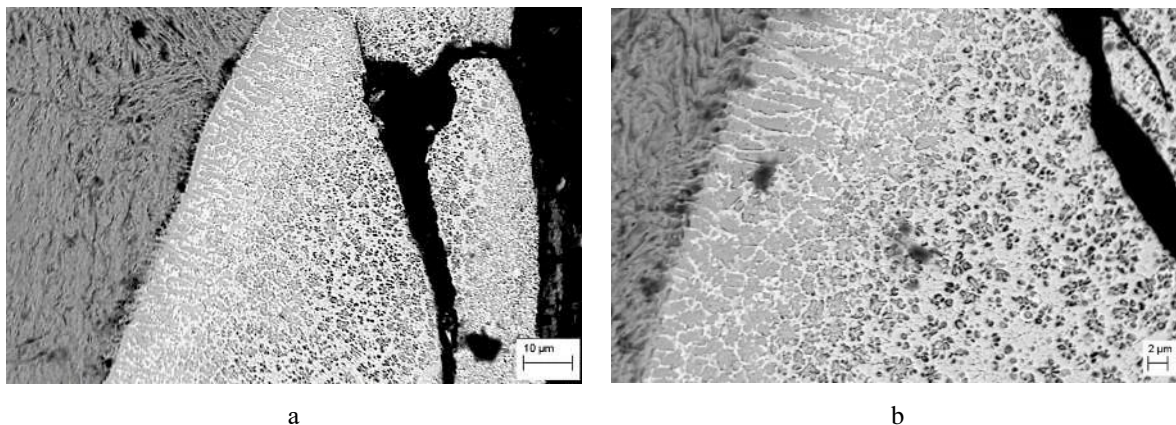
At the boundary of the surface-strengthened layer and the base of 15Kh11MF steel blade plate, a chain of pores up to 7 μm in size, caused either by the Kirkendall effect (due to unequal counter-diffusion of alloying elements across the boundary between the blade and the ESA layer), or by unsatisfactory preparation of the surface of the blade before use was observed.

Figure 5. Chains of pores at the boundary between the base metal and the surface hardened layer formed by electrospark alloyed method

Tensile stresses of up to 500 MPa can occur at the boundary, which, when combined with the working stresses acting on the blade, can significantly affect their fatigue life (especially under the influence of condensate with aggressive components dissolved in it) and, thereby, significantly reduce their service life. These chains facilitated the penetration of cracks from the electrospark alloyed layer into the base metal of the blade, and, therefore, contributed to the destruction of the blade.

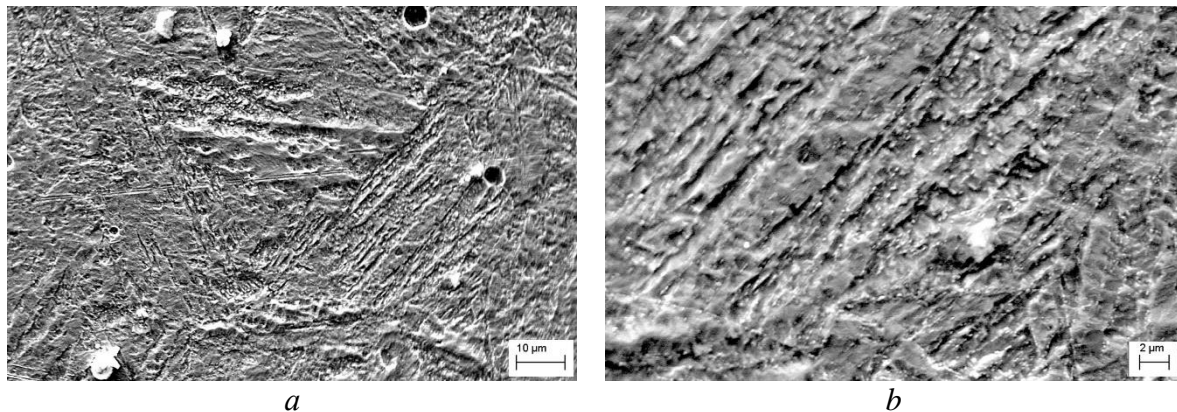
A loosely structured layer of the base metal of the blade up to 10 μm thick was adjacent directly to the surface hardened layer using the electrospark alloying technology, within which the needle structure of sorbite (high-tempered martensite) was less clear than in the base metal of the blade. In general, the blade plate steel had a sorbite-like pearlite structure that inherited the martensite parallel crystal packet morphology characteristic of this type of hardened steel after high tempering. A fairly uniform distribution of crystal sizes in the blade was noted, which

is obviously due to the uniform distribution of former austenite grains by size, within which martensite crystals were formed (the average grain size was 52 μm) (Fig. 6 *a*).

Figure 6. Microstructure of the base metal of the of steam turbine rotor blade
