RESULTS OF THE TECHNICAL SURVEY OF THE HISTORICAL ARCHIVE OF UKRAINE AT SQUARE SOBORNIY IN LVIV

Abstract. The article highlights the results of the technical inspection of the Central State Historical Archive of Ukraine building on the 3a Soborna sq., Lviv. The building was built around 1620. It is an architectural monument of national importance and an integral part of the architectural complex, including the Bernardine church. The building is attached to the northern wall of the church, and from the east, it is surrounded by walls with an entrance tower. The portals of the 17th century have been preserved in the interior and fragments of 18th century paintings. In the plan, the building has a complex configuration, and its body covers a square inner courtyard. The building is made of brick, three- and partly four-story. The walls are reinforced with stone buttresses. Tracking indicators of the technical condition of the load-bearing structural elements of the building makes it possible to determine the technical condition of individual elements and the building as a whole [1].

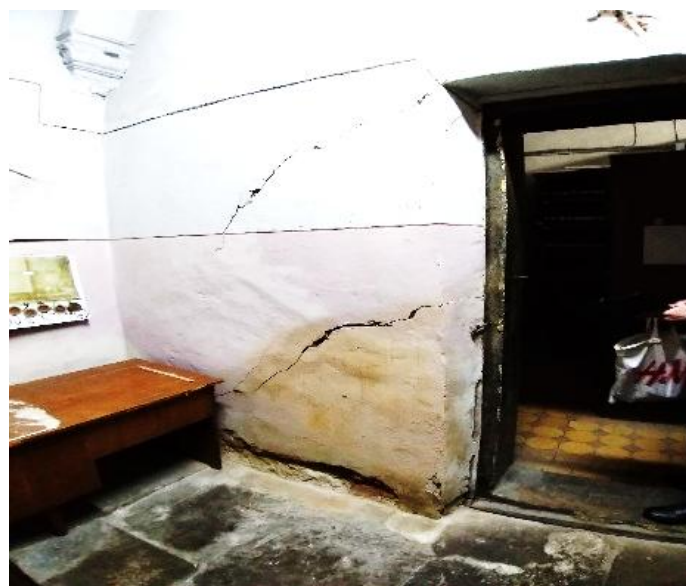
Figure 3. Oblique cracks in the wall with a width of up to 2 cm, floor deflection within the first floor between axes 4...5

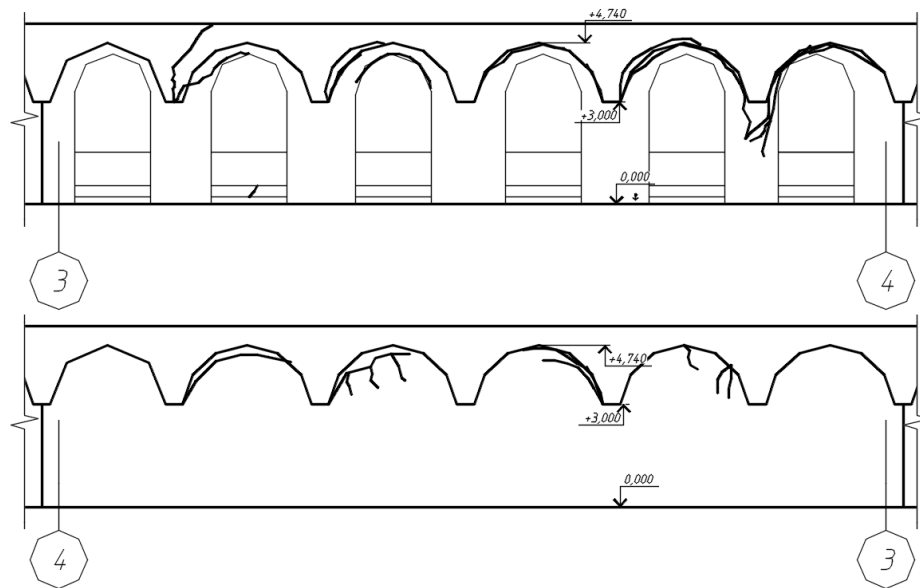
Figure 8. Scheme of defects along the B and G axes

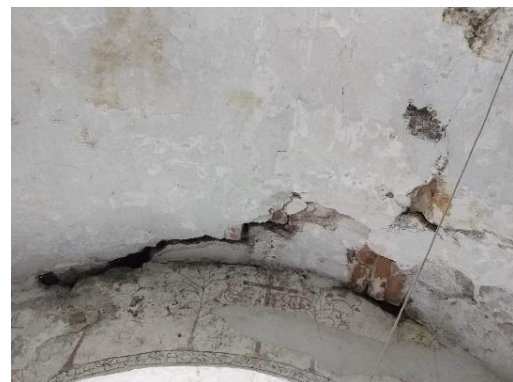
Figure 10. A crack with a width of up to 2 cm. in the place where the wall adjoins the ceiling within the 2nd floor along the G axis
